"Fireboat Gets Balky At Critical Moment During Bridge Fire"

"Steel Beams Are Warped By Heat Of Bridge Blaze"

Source - Oregon Journal Evening Edition
July 31, 1913

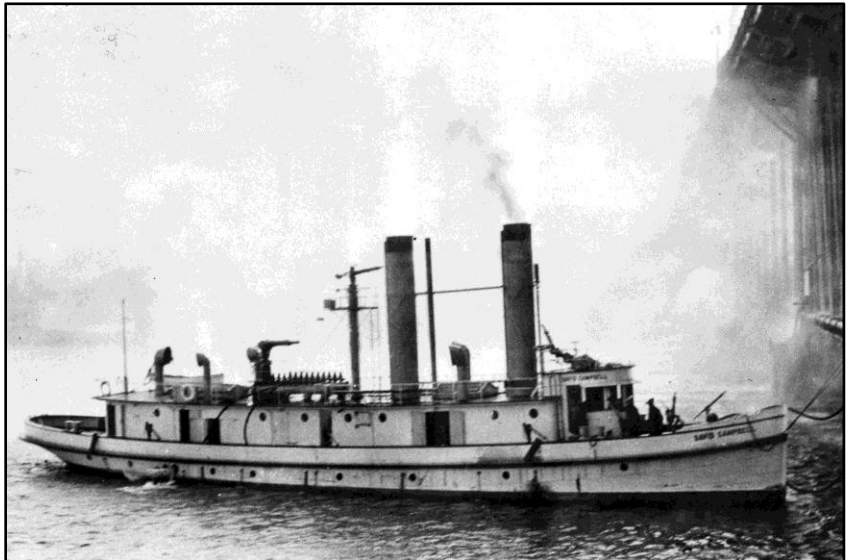
Becoming balky at a critical moment at yesterday's bridge fire, Portland's new \$125,000 fireboat, the *David Campbell*, swerved into the railroad span of the burning structure, and the large forward bridge 8 inch nozzle, the big searchlight, and some minor brasses were crushed in as a result of the collision.

The *David Campbell* did not perform very satisfactorily at yesterday's fire, and in fact, she has not at any time performed in action as she did at her trial tests made last June just prior to the city's official acceptance of the craft. Though she made a rapid run yesterday from her berth at the foot of East Washington Street to the railroad bridge, there was some delay in getting water through the nozzles, and when it did come, the flow was intermittent. There was much the same trouble at the recent Fisher & Thorsen paint store fire at Morrison and Front Streets, and though the *Campbell* did good work there, those in command could not get action as quickly as desired.

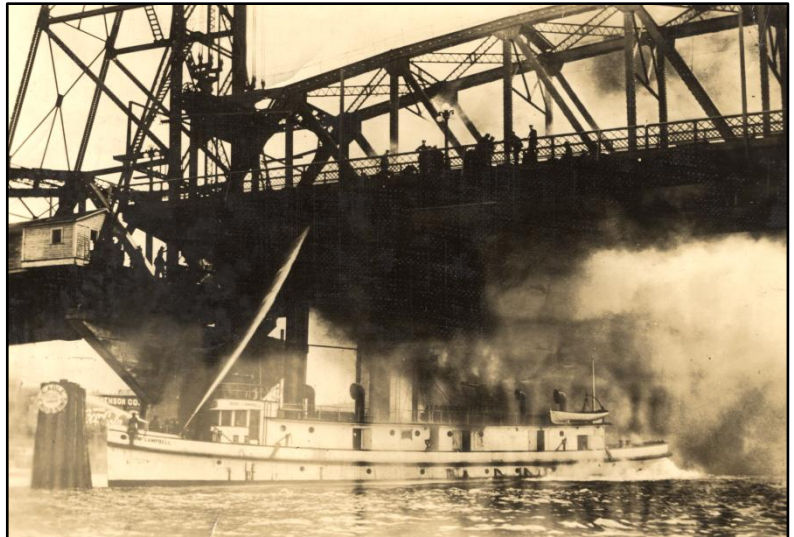
The Campbell made a splendid showing on her trial trips and tests, throwing great streams of water two thirds of the way across the river at Stark Street and averaging 16 $\frac{3}{10}$ miles an hour on a speed test, but on these tests, she was manned by a full crew, probably three or four times as many men in the engine room as the two who attempted to handle the boat yesterday.

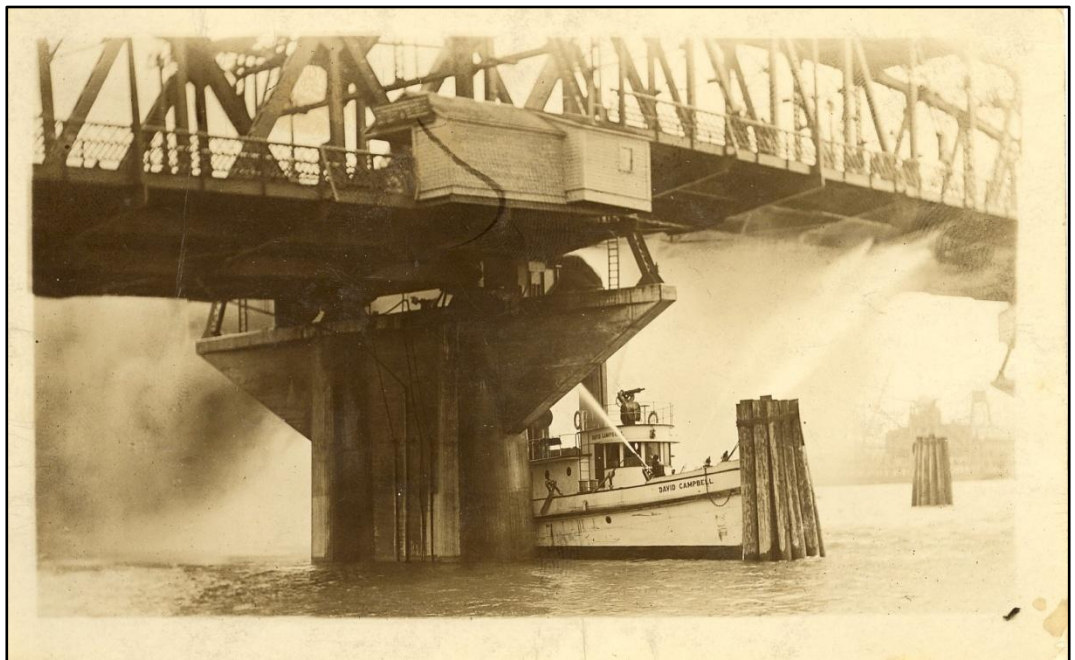
"The current in the river made it necessary to keep the propeller going to maintain position, and to offset the back pressure from the streams. We bumped into the bridge yesterday when the water cut off unexpectedly, and the accident was unavoidable."

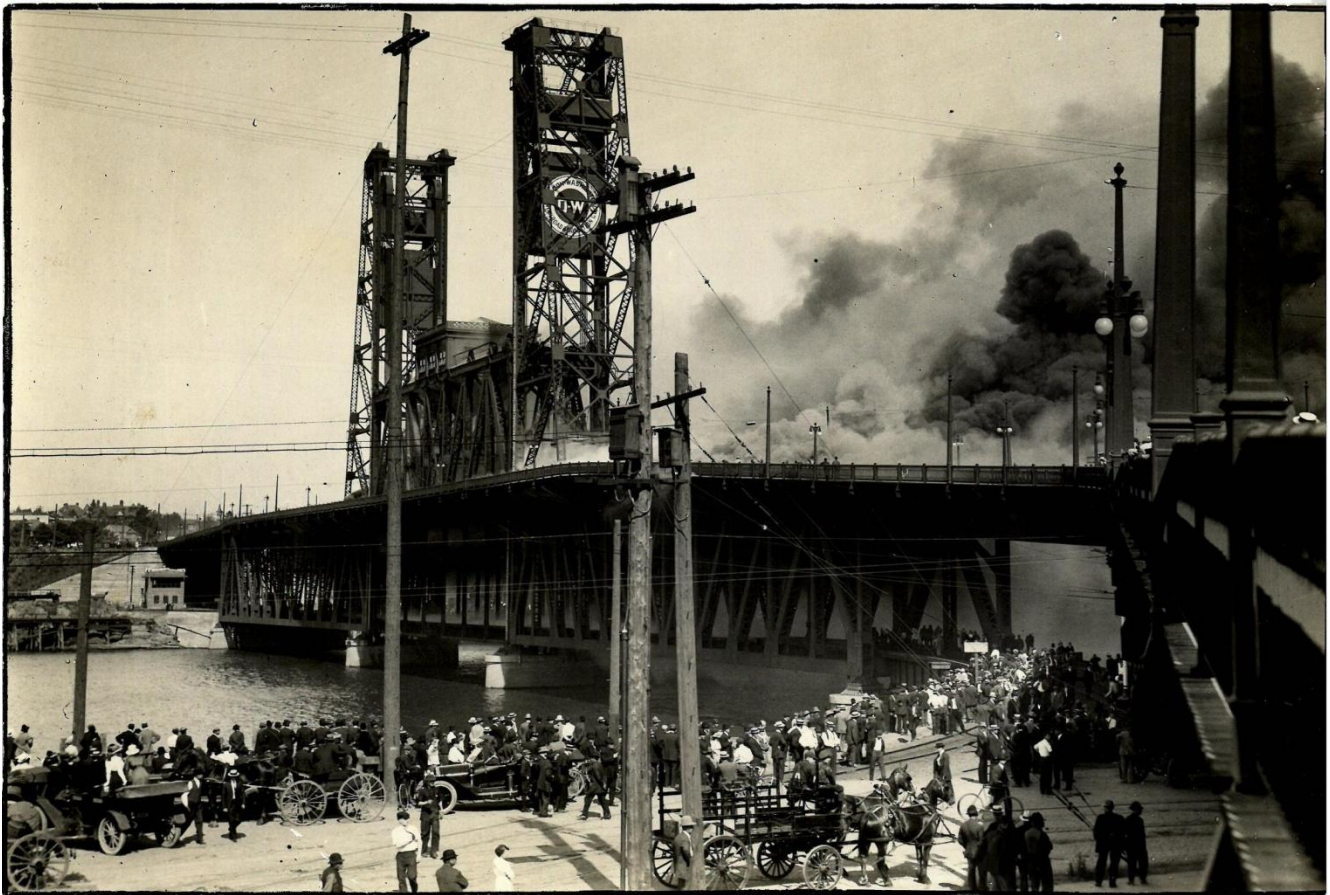
The origin of the fire is believed to have been a lighted cigar or cigarette butt. The point of origin was in the southwest corner of the lift span.

of eight end cables of the lower lift, the bridge is intact," said he. Mr. Boschke estimated the area of pavement burned on the upper deck at 12,000 square feet. The upper roadway of the bridge has, for its own base, heavy creosoted planking. On this is a layer of tarred paper upon which the paving blocks are set. The interstices were filled with tar rendering the whole roadway highly inflammable. The fire burned rapidly and produced great heat, extending throughout a great part of the roadway on the lift span.

An inspection of the upper deck of the bridge today showed that the lift span of the bridge at the west end is three or four inches out of alignment. The guide wheels on the runway of the lift were off their track. A number of bolts holding the big girders had been sheared off. The southwest supporting post had buckled from the heat three inches at least and the steel girder underneath appeared to have warped. All the electrical connections were virtually out of commission.

The soldered joints and insulation had burned away. Eight of the steel cables of the lower lift were broken. All the sidewalk on the south side, save a short space in the center, was a charred mass. On the roadway where holes had been cut the wooden beams beneath were seen to be charred, also. There were similar conditions on the north side, but the fire was much less in intensity here, owing to the fact

that the breeze blew the fire southward. Between the roadway and the sidewalk for 50 feet on the west side of the lift, and for a distance of 30 feet on the other side, the flooring had burned away, exposing the steel work.
