# Portland Oregon Fire Hydrants

*Revised December 12, 2003*

Provided by Portland Water Bureau – Edited for presentation by Don Porth

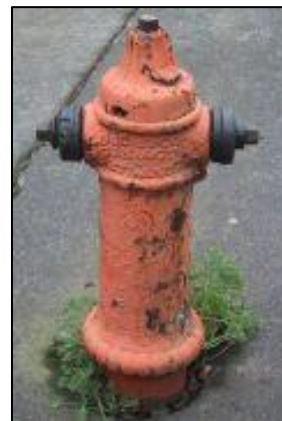
The Long & Scott fire hydrant is essentially a Waterous frost jacket hydrant. The barrel was manufactured in Portland by Long & Scott, while the bonnet and (presumably) the valve mechanism were manufactured by Waterous in Saint Paul. It may have been cheaper in the 1890s to have a local company manufacture the cast iron barrels under license than to ship them roughly 1,500 miles from Saint Paul to Portland.

Rather than being a hybrid constructed from standard Waterous parts, the Long & Scott hydrant seems to have been manufactured with this arrangement in mind. The Waterous bonnet is a different shape than usual, and "ST. PAUL MINN" is cast on the back of the barrel instead of in its usual place on the bonnet.

There are only two known Long & Scott hydrants in service. Another survives at the Water Bureau. The bonnets seem prone to cracking, so this is the only one with its original bonnet, though signs of repairs are visible.

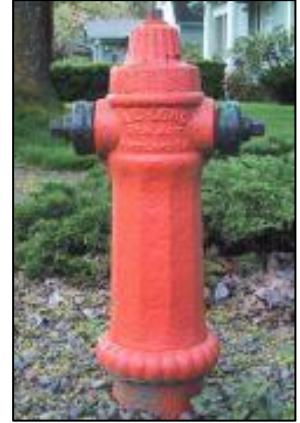
Portland Water Board hydrant records begin in 1904 and show no purchases of A.G. Long hydrants. A.G. Long didn't exist prior to around 1894, so this hydrant was likely manufactured between 1894 and 1903. It's also possible that it may have been manufactured after 1904 and later "inherited" by the City from another utility. However, its similarity to the Long & Scott hydrant suggests strongly that it was manufactured during the 1890s.

This is probably the last A.G. Long hydrant in Portland, though later models are still fairly common in Astoria, Oregon. The bonnet of this hydrant has cracked in a manner very similar to the Long & Scott hydrant above.

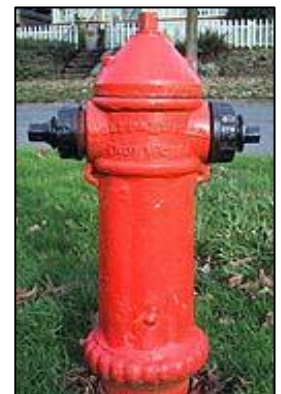
### **1888-1902 Wolff & Zwicker Iron Works Hydrant**

Wolff & Zwicker Iron Works manufactured a frost jacket hydrant that could be the Waterous design's twin but for a few details. It has a generic bonnet held on by two bronze bolts, and the barrel is fluted rather than having flat facets. Like Waterous hydrants of similar design, these have no dates on them. Fortunately, Wolff & Zwicker were only in business for about 15 years so that limits the range of possible dates considerably.

A firm of machinists called "Trenkmann & Wolff" existed in Portland until about 1888, then that company disappeared and "Wolff & Zwicker Iron Works" shows up. Wolff & Zwicker were in business until about 1902, when they were replaced by Phoenix Iron Works (below).

Although it is possible that these hydrants were manufactured as late as 1902, the Fire Department had already switched to larger and more complex designs by 1900 or so. These hydrants were likely manufactured in the early 1890s.

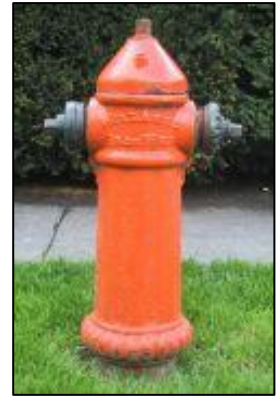
Except for the manufacturer's name cast on the barrel, the Willamet hydrant is identical to the Wolff & Zwicker Iron Works hydrant. Whether this similarity is because of a city specification or some connection between the two companies is currently unknown.

Willamet Iron Works is better known as Willamette Iron and Steel, manufacturer of everything from war ships to forklifts to steam locomotives. When the company was formed in 1865 it was called "Willamette Iron Works". For some reason the spelling was changed to "Willamet Iron Works" in about 1889. Then the name was changed again, to "Willamette Iron and Steel Works" in 1900 or 1901. These hydrants all have the "Willamet" spelling cast on the barrel.

Despite the earlier spelling of the company name on the barrel, city records usually refer to these hydrants as "Willamettes." There are probably one or two dozen Willamettes in service today. They are usually found in the same places as Wolff & Zwicker hydrants and both types are often found within a few blocks of each other.

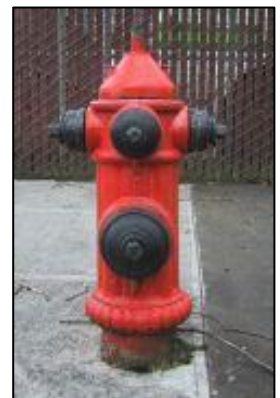
### **Unidentified 4-Port Hydrant**

Most of Portland's locally manufactured hydrants are undated but do have clear manufacturer's marks. Unfortunately, this design has neither. Except for having "Portland ORE" cast on the back of the barrel, it is unmarked.

There are just two hydrant designs in Portland with three hose ports, and neither of them are especially numerous. The four-port specification may have been very short-lived or only used in certain places. All known examples of this hydrant design are located along the same street. That water main was laid in 1902.

This design shares the cosmetic details of the Willamette/Wolff & Zwicker hydrants, so it's possible that one of those companies manufactured it. It also shares the same conical bonnet used by both those designs. (The bonnet appears smaller because of this hydrant's larger barrel diameter.) Phoenix Iron Works, which manufactured Portland's only other four-port hydrant, was formed in about 1902. That may have been early enough to make Phoenix the manufacturer of this design as well.

Only four of these hydrants have been found, and they are probably the last ones in town.

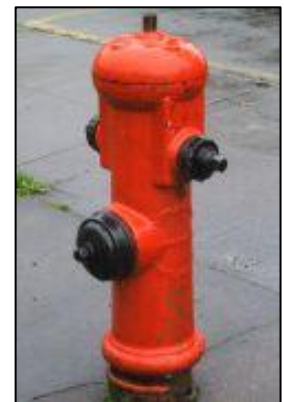
### **Smith & Watson Iron Works "Portland" Hydrant**

Smith & Watson Iron Works was in business from 1896 until the 1920s. It looks like Smith & Watson were just getting out of the hydrant business at about the time the Water Board started purchasing them. The company did submit bids for hydrants in 1904 and 1905, but the Water Board did not purchase them. There are no further records showing that Smith & Watson ever bid on another hydrant contract.

The almost total lack of any mention of Smith & Watson hydrants in the City's old installation and maintenance records also points to this design being installed prior to 1904. What records do exist show individual hydrants being replaced or repaired.

The most common variety of "Portland" hydrant is the Oregon Foundry type. In addition to the company logo on the right side of the barrel, it also has "P. F. D." in large cursive script on the left side. Aside from markings, these hydrants are identical to the Smith & Watson hydrant.

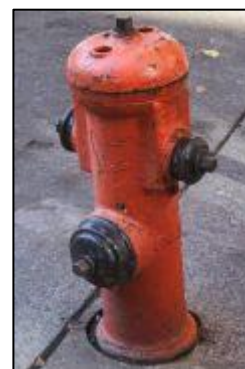
### **Oregon Foundry "Portland" Hydrant**

Oregon Foundry was in business from about 1900 until at least 1910. The Oregon Foundry version of the "Portland" hydrant was probably manufactured before 1902, since the Howes patent hydrant (below) came along in 1902. Records showing Oregon Foundry hydrant bids do exist for 1904 and later. The Howes hydrant was the only design that Oregon Foundry offered from at least 1904 on.

Slightly more common than the Smith & Watson version, and found in all parts of the city, there are still a few dozen Oregon Foundry "Portlands" in service.

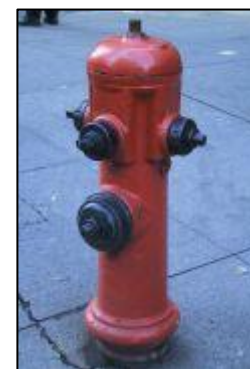
### **Phoenix Iron Works "Portland" Hydrant**

The Phoenix version of this hydrant sports a third hose port, indicating that it may have been built somewhat earlier or later than the Oregon Foundry or Smith & Watson versions. Since adding a third hose port, especially one with an independent valve, would add to the cost of the hydrant, it's likely that the specifications at that time demanded it.

Portland's only other four-port hydrants have been tentatively dated 1902. That's right about the time Phoenix Iron Works opened its doors, and about the same time that the other "Portland" hydrants are thought to have been made.

Broadway downtown has the only large concentration of these hydrants. The rest, maybe a dozen in total, are widely scattered around the city.

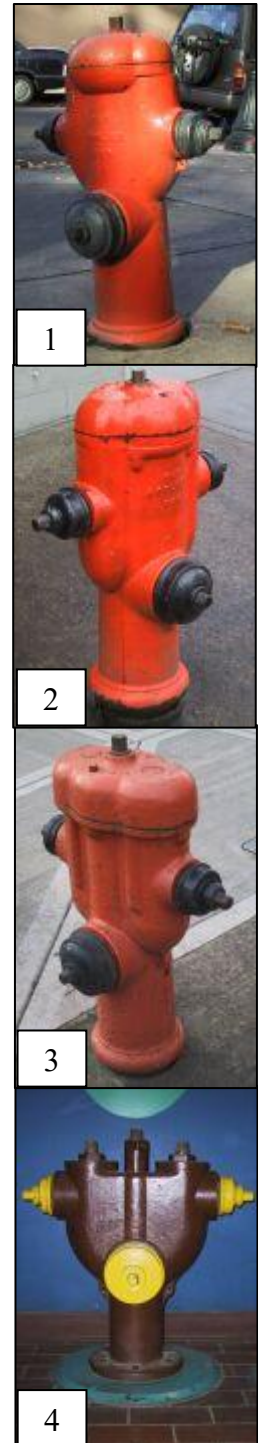
### **1902-1910 Oregon Foundry Howes Patent Hydrant**

Claude L. Howes developed a new style of port valve for fire hydrants. He was granted U.S. Patent number 733,483 on July 14, 1903. Howes' design called for large, elliptical valve chambers running vertically through the hydrant body. These spacious chambers would allow easy access to the valves for maintenance and allow water to flow unimpeded through the valves when opened. It is these later internal valve chambers that give the Oregon Foundry Howes hydrant its distinctive shape.

4. **(Not Shown)** - Some examples of the "Type C" have no markings on the barrel at all. This is the least common version of Howes hydrant still in service. Only two of this type are known to exist, though some may have been mistaken for "Type C" hydrants since they are identical from the front. Just 25 Howes hydrants were purchased in 1910, so these unmarked hydrants may have been from that batch.

5. **Unknown** - This design is not in service anywhere in the city. The only known example is on display in the Portland Water Bureau offices. It appears to be a very late design based on the Howes patent. The valve cylinders and chain lugs suggest that this design is newer than other types. It also has a two-piece barrel, a feature that was not common in Portland until the 1940s. This may have been a special purpose design not intended for normal street use.

Howes hydrants can be found anywhere frost jackets were installed. The largest concentration is downtown, where examples of all four in-service types (1-4) can still be found.

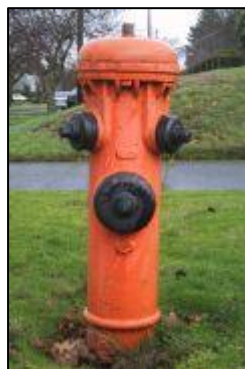
### **Possible Phoenix Iron Works Hydrant (?)**

Another ambiguous hydrant design. Except for "The Phoenix" cast in large characters on the bonnet, this design has no identifying markings. It is assumed that this design was manufactured in Portland because it has not been documented anywhere else. The logo on the bonnet suggests that it was manufactured by Phoenix Iron Works, though Phoenix does place a clear company name and location on two other hydrant designs.

These hydrants are old, almost certainly older than 1915 (which is the time of the oldest maintenance records on many of them). They are almost always referred to in Water Bureau records as "Phoenix" type hydrants, which is the same designation normally used for known Phoenix designs from 1902 and 1912. There are no significant installations of Phoenix hydrants after 1912, and no unknown types that could account for these hydrants being installed after 1912. Records of contracts awarded show that Phoenix Iron Works made 200 hydrants of a type called "Fire Dept." in 1905. This may be that design. The independently gated hose ports on this design indicate that they were probably manufactured before 1912 in any case.

There are probably 40 or 50 of these hydrants around Portland. They tend to show up in areas where Coreys are common rather than the older frost jacket sections of the water system.

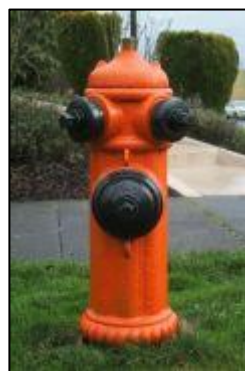
Despite being modernized to include angled hose ports and a steamer port, the 1912 Phoenix looks remarkably similar to the old Willamettes. This would be the last of Portland's really decorative hydrants.

The resemblance to earlier hydrants is understandable based on what is known about the formation of Phoenix Iron Works. In 1902, Wolff & Zwicker Iron Works disappears from local business directories and a new company called Phoenix Iron Works appears. Listed among Phoenix' management is one "Fritz Wolff – Superintendent and Manager," undoubtedly the same Fritz Wolff who had been President of Wolff & Zwicker Iron Works.

Phoenix Iron Works created at least two, possibly as many as four, hydrant designs for the city of Portland. There are no dates on any of them, but Water Bureau records from 1913 comment on the similarity between the Helser & Uden hydrant (below) and hydrants previously purchased from Phoenix Iron Works. Since this design and the 1913 Helser & Uden are nearly identical in all ways save decoration, this should be the 1912 Phoenix.

The Portland Water Board purchased four hundred of these hydrants, and many of them are still in service today. They can be found all over the city, though seldom in large groups.

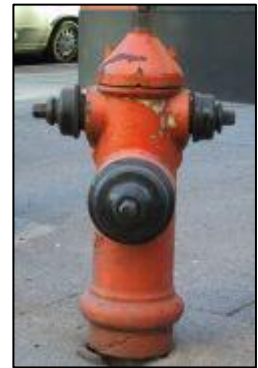
### **Possible John Wood Iron Works Hydrant (?)**

The most ambiguous of Portland's fire hydrants, this design is completely unmarked. No manufacturer, no date, no city, no valve size, not even an arrow to show which way the valve opens. It is similar in design to other Portland frost jacket hydrants, and uses the same conical bonnet found on the Willamette/Wolf & Zwicker designs.

The conical bonnet suggests that this hydrant was manufactured around the turn of the century. The presence of a steamer port indicates that it is newer than the Willamette/Wolff & Zwicker designs. It may be from the previous period of frost jacket hydrants, but its similarity to other designs in this section, the large numbers remaining in service, and evidence of missing "Wood" hydrants, all indicate that the design belongs here.

The manufacturer is currently unknown, but circumstantial evidence suggests that these hydrants were purchased from the John Wood Iron Works Company at the end of 1912. Little is known about the company except that they were in business in Portland during the early 20th century.

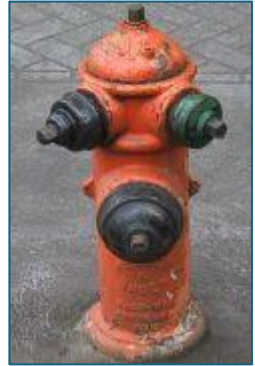
The 1913 Helser & Uden hydrant is essentially a less decorative version of the 1912 Phoenix Iron Works hydrant (above). Following the pattern of earlier designs, this hydrant shares a common bonnet with the 1912 Phoenix. These bonnets are technically interchangeable with the conical type, but larger in diameter.

Helser & Uden were in business as machinists for years before they started manufacturing fire hydrants. Their first attempt at a hydrant contract from the city (bids opened January 1913) was successful, and Helser & Uden hydrants were installed starting in March or April. Little else is known about the company during this period. By the 1920s the company had been renamed Helser Machine Works.

Portland made just one purchase of 350 hydrants from Helser & Uden in 1913. Thus, all Helser & Uden hydrants were manufactured in 1913. Many of these are still in service today. Like the similar Phoenix design above, these hydrants can be found scattered across the city anywhere frost jackets were installed.

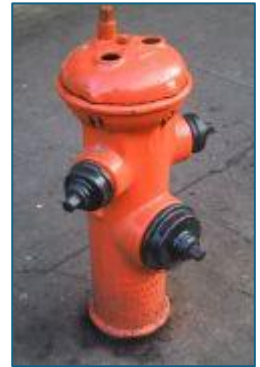
Rensselaer hydrants of the same type may have either large or small openings in the bonnet for the port valve stems. All Helser bonnets have large openings or (after the valves were discontinued again) no openings at all.

During the 1920s, Helser Machine Works briefly changed its name to "Helser Machine & Marine Works" and that name appears on some of their hydrants. There are still hundreds of these hydrants all over the city.

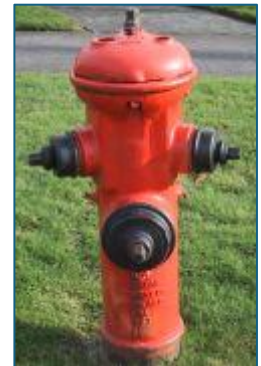
### **1927 Western Foundry Gated "Corey"**

The Western Foundry independently gated Corey is, naturally, identical to both the Rensselaer and Helser versions. Almost nothing is known about Western Foundry itself.

Gated Western Coreys are uncommon, but they blend in with the rest of the population, making an accurate estimate of their numbers difficult.

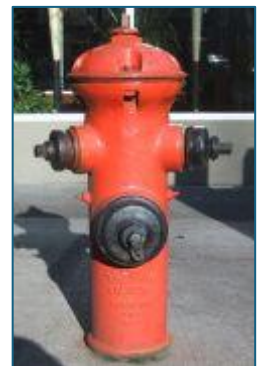
### **1931 Western Foundry "Corey"**

By the 1930s, independent hose ports valves were out, but the Corey specification continued.

There are at least 40 or 50 ungated Westerns left in service, including some large patches in the Eastern suburbs.

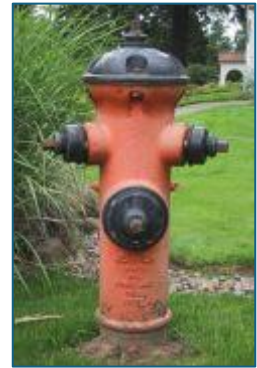
### **1933 Helser Machine Works "Corey"**

The 1933 Helser Coreys are the last known fire hydrants made in Portland. Rensselaer Coreys continued to be the mainstay of Water Bureau hydrant purchases into the 1950s.

Due to a leaking problem with the valve mechanism, many of the 1933 Helser Coreys have been removed and replaced. Some of those that remain have been refitted with different valve mechanisms from older hydrants. The handful of unmodified examples that remain are in remote parts of the city and/or water system.
